2007 Engineers Australia, Engineering Excellence Awards

SCORPION CREEK BRIDGE REHABILITATION, VICTORIA HIGHWAY, KATHERINE REGION

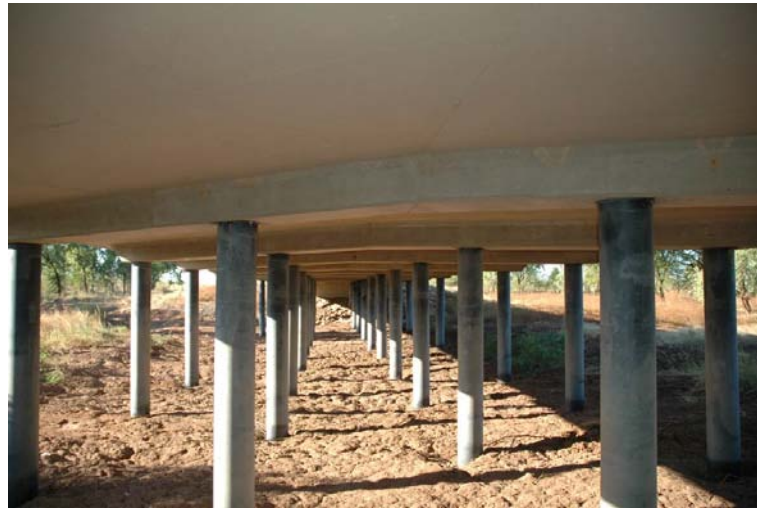
Photo 1 – Scorpion Creek Bridge in late 2005, before the 2006 wet season

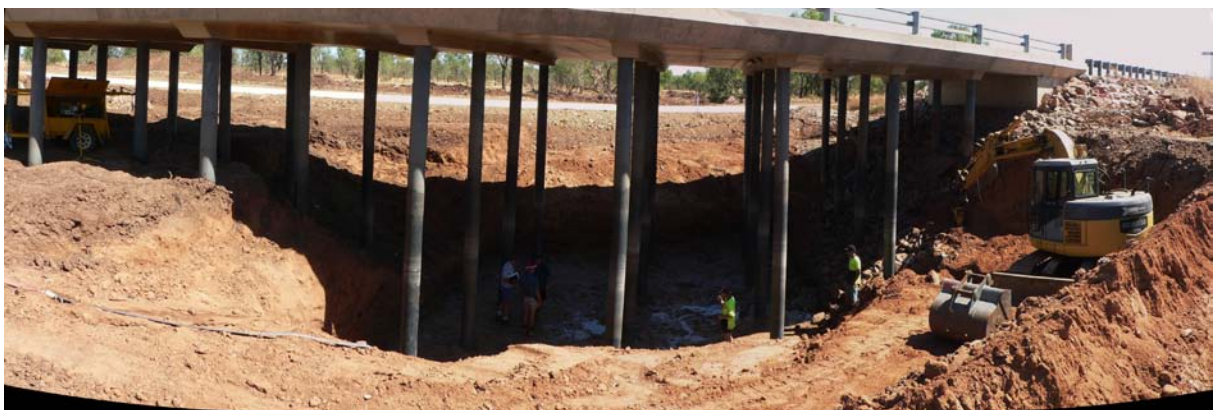
During a routine inspection in mid July 2006, Department of Planning and Infrastructure (DPI) officers in Katherine noticed the bridge had suffered large amounts of scour underneath the envelope of the bridge. (Photo 2) The large scour had not been noticed until the inspection due to the high water levels from the preceding wet season hiding the evidence. The DPI Katherine Office requested an inspection by DPI structural engineer, Louise McCormick to assess the condition of the bridge. No structural damage was evident at the time.

Photo 2 – Scorpion Creek after the 2006 wet season

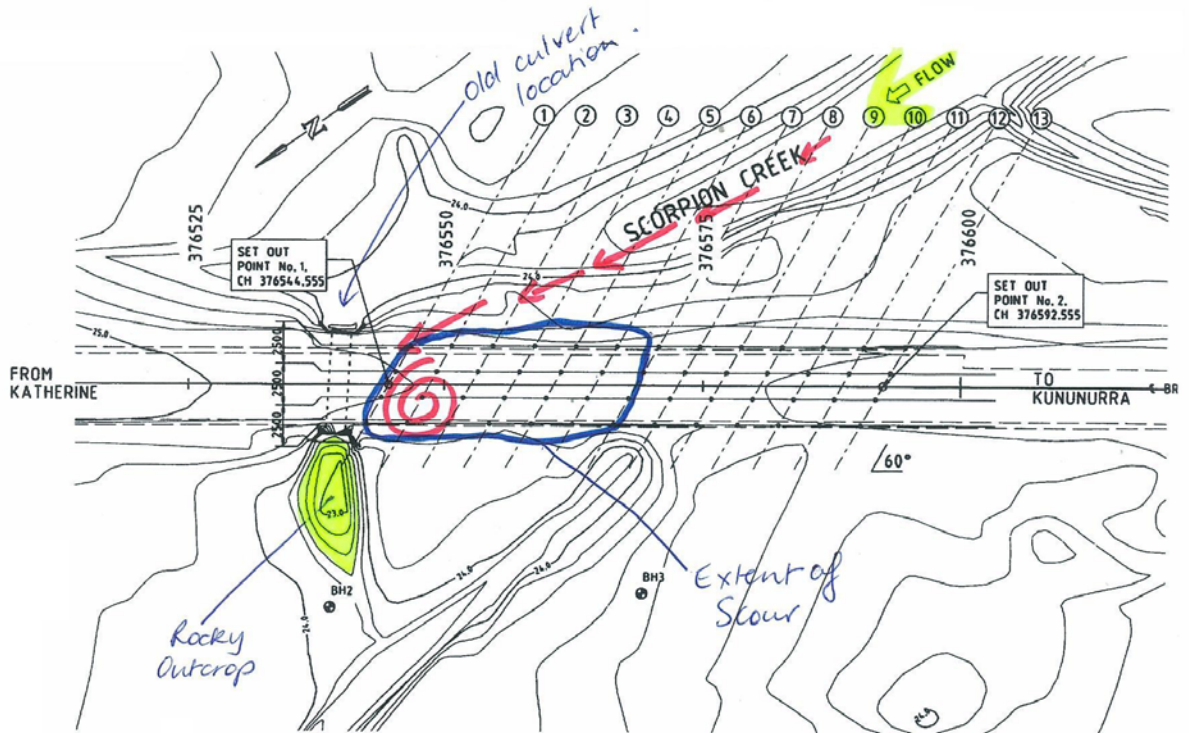
Upon inspecting the site, Louise concluded that the skew of the creek flow was hitting against a natural bank of hard shale. The extended wet season weakened the soil profile and the shale bank effectively concentrated the flow at the abutment creating one large eddie/whirlpool that continuously scoured the one position. The final scour depth was approximately 5m. Figure 1 shows the flow profile that created the scour.

Figure 1 – Flow path of creek to encourage scour

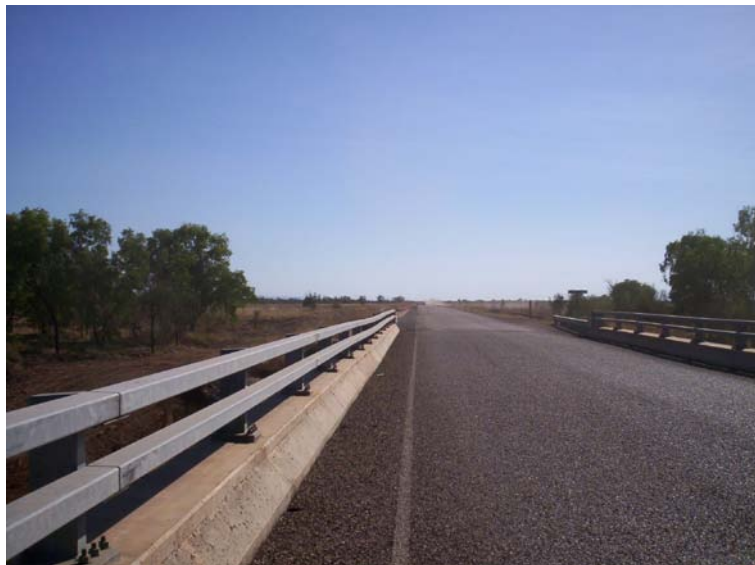
Whilst the structural assessment report was being finalised, an unknown, overloaded vehicle is assumed to have crossed over the bridge at a great speed to produce enough impact on the bridge deck to puncture the piles through the underlying shale. This is the only plausible reason for the settlement as the bridge had withstood the scour for approximately 4 to 5 months without any signs of structural distress. DPI inspector Mal Hunnam, was the first to notice a large deflection in the bridge rail and closed the bridge to traffic immediately. (Photo 3)

Photo 3 – Deflection in the bridge rail

The DPI Katherine office immediately contacted structural engineer, Louise to inspect the damage. The inspection found that the bridge deck had deflected approximately 100mm (later surveyed to be 75mm). In bridge terms, this is a very large deflection and much larger than the code defined Span/800 allows. (The spans on Scorpion Creek Bridge are all 4000mm, which gives an allowable deflection of 5mm!)

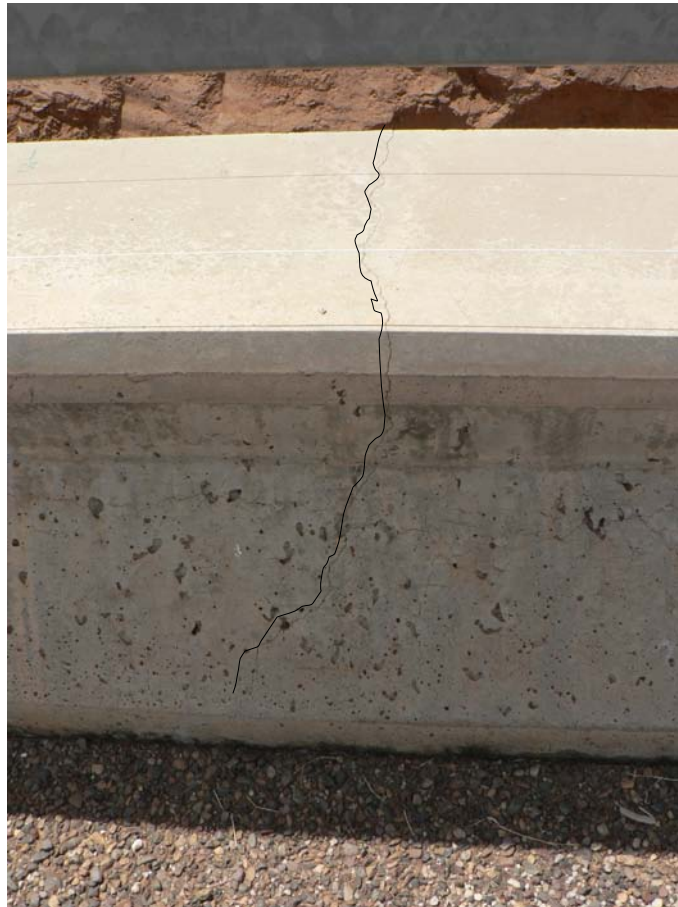
Many structural cracks through the full depth of the kerb appeared where they had not been previously. (Photo 4. Note that a line has been superimposed to clearly map the typical crack pattern)

Photo 4 – Cracked kerb section

The kerb cracking clearly identified that there was an overstress problem. The change in support conditions for the deck produced tensile forces in the tops of the kerbs at the point of contra flexure. Figure 2 gives a graphical representation of the normal bending conditions of the deck under dead load and Figure 3 shows the over stress condition. Note in Figure 2 that the tensile stresses in the top of the deck are relatively even under dead load and in Figure 3 the vast difference in tensile and compressive deck stresses, again under dead load.

Analysis of the crack patterns and support conditions lead to one logical solution – to jack the bridge back into the original position. Jacking the bridge into the original position would relieve the deck stresses. Strengthening of the foundations was also investigated to prevent this happening again if scour occurs in future wet seasons.

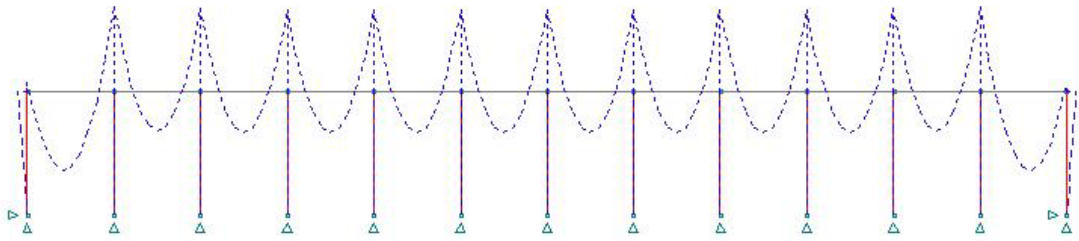
Figure 2 – Normal deck Stresses

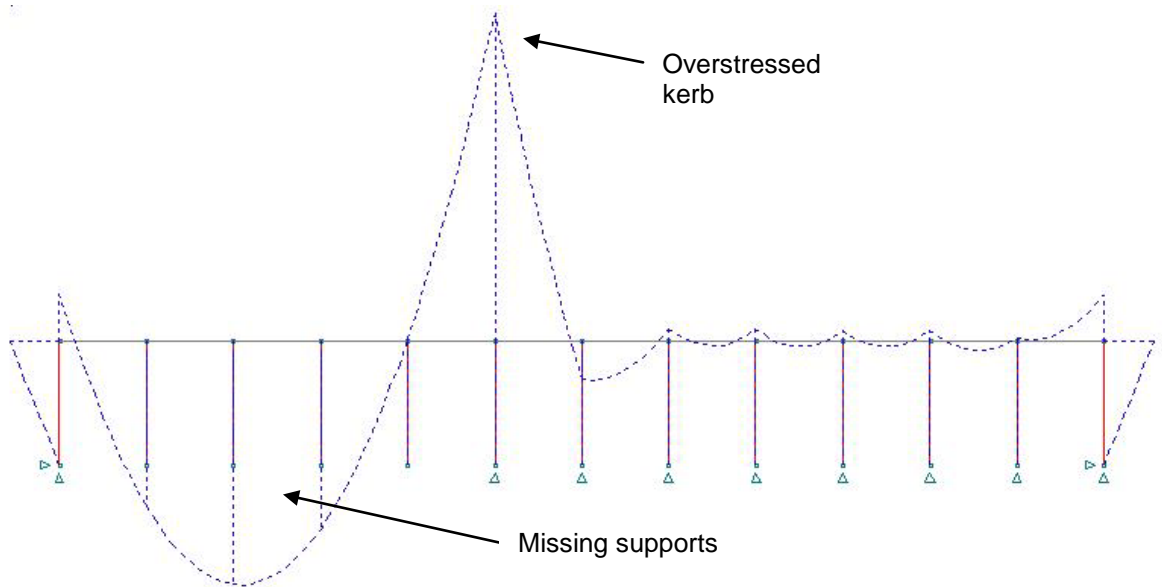
Figure 3 – Overstressed deck condition

The supporting soil that created friction forces for the steel piles had completely scoured away. This reduced the support capacity and effectively allowed the steel piles to puncture through the rock with the overload.

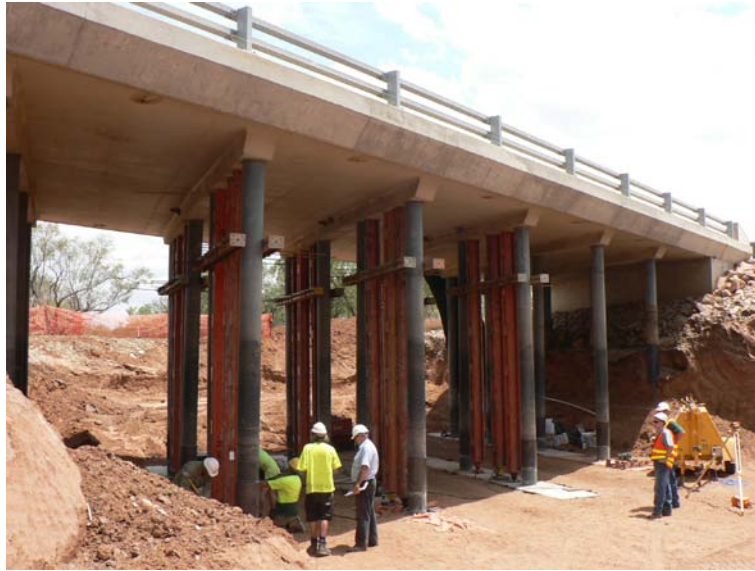
Photo 5 – Scorpion Creek Bridge Jacking

Due to the length of time the highway had been closed and the looming wet season approaching, Advance Civil Engineering slightly modified the DPI design to decrease the time it took to reopen the highway. Six, 100t hydraulic jacks and Megashore props were used in succession to jack the bridge into position. Extra Megashore props were used to provide the safety supports to the bridge in case of a jack blow out. Photo 5 shows the general arrangement of the jacking equipment and photo 6 gives a closer view of the jacks and propping.

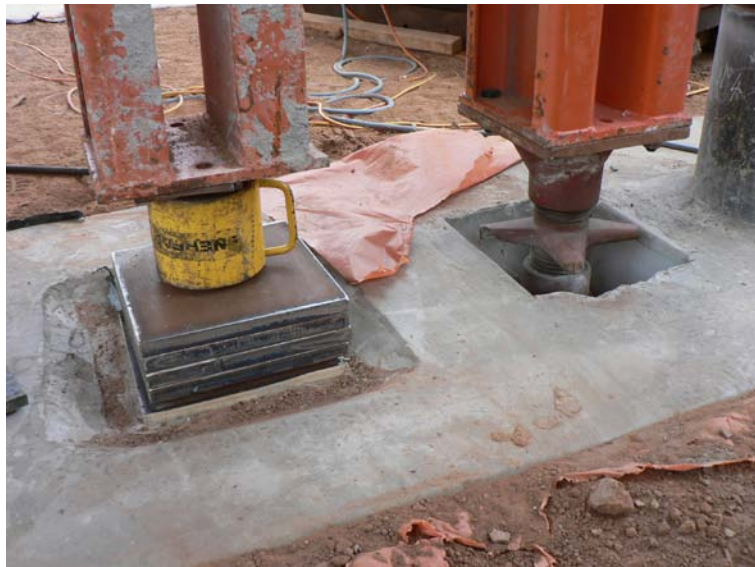
Photo 6 – Hydraulic jack and Maegashore support

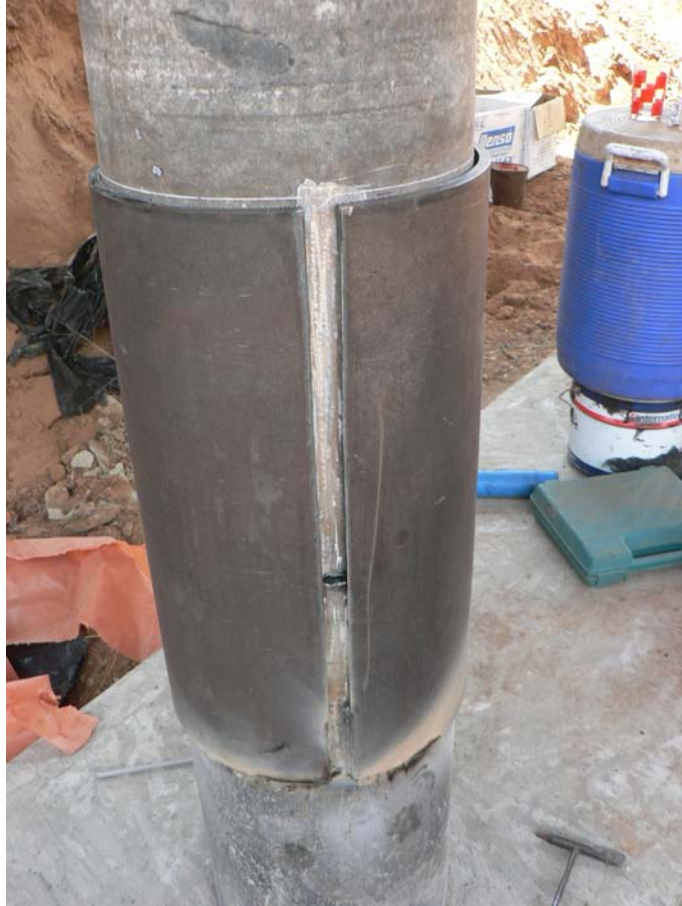
Photo 7 – Steel sleeves around piles to be jacked

The new foundations were also designed to act as the strong points for the bridge jacking points. However, this presented problems with the existing steel piles and their attachment to the new foundations. Advance Civil Engineering proposed casting of the existing piles into the new foundations, supporting the bridge from the Megashore props, cutting the existing piles and welding new steel sleeve to the extension of the existing pile. This worked remarkably well. Photo 7 shows one of the steel sleeves used on the project.

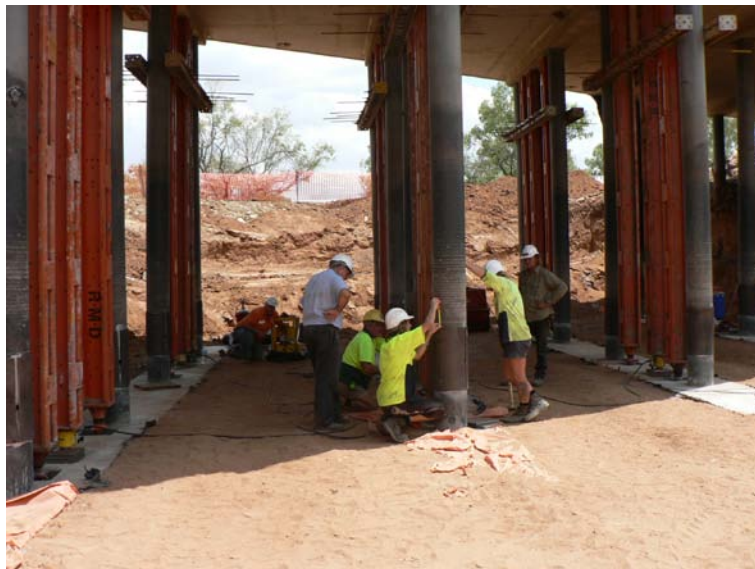
Photo 8 – Measuring the amount of displacement

The steel sleeves were also used to provide a datum point for measuring the displacement on each pile as the jacking progressed. (Photo 8 and Photo 9)

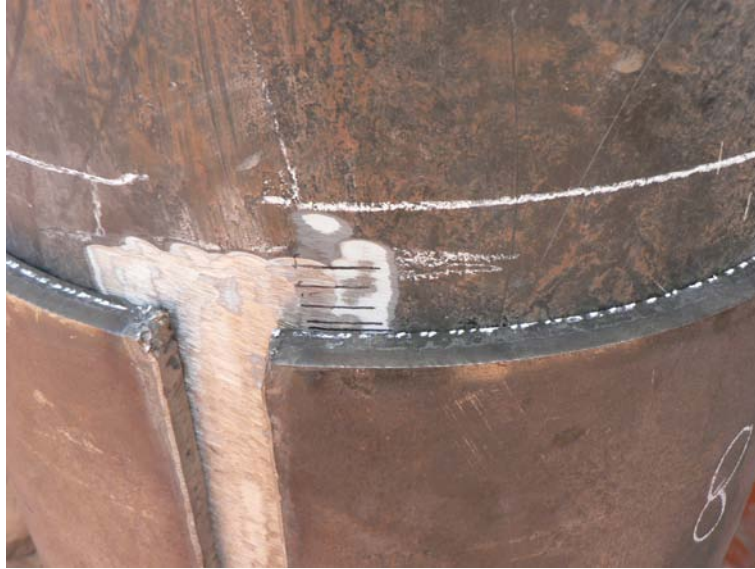
Photo 9 – Amount of displacement on pile sleeve
